Gotham City Home Inspections Inc.

391 Any Street Apt. 4, Brooklyn, NY 11215
Inspection prepared for: Sample Report
Date of Inspection: 10/8/2013 Time: 4:00 pm
Age of Home: Built app. 1899 Size: Condo
Weather: Partly Sunny

Inspector: Tony Castoro
License #16000054820
2045 Bay Ridge Parkway, Brooklyn, NY 11204
Phone: (718) 360-1868
Email: tonyc@abrooklynhomeinspection.com
<http://www.abrooklynhomeinspection.com>

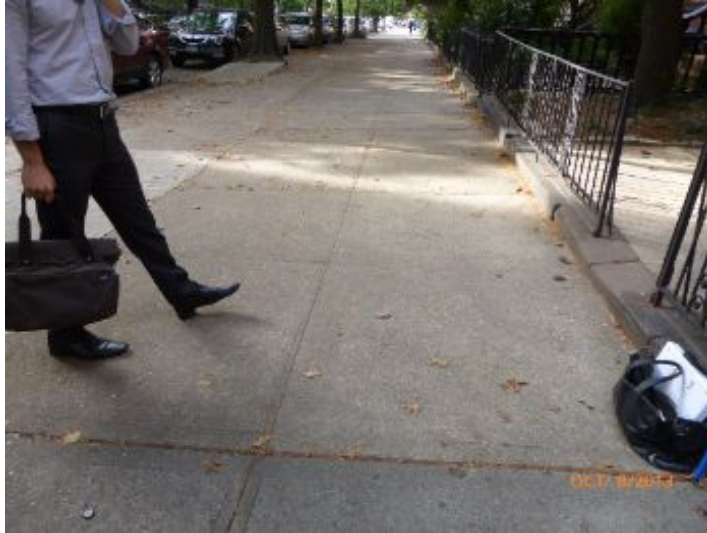
- Public walkways are functional, common cracking noted,
- Walkways are generally in serviceable condition

Public walkway

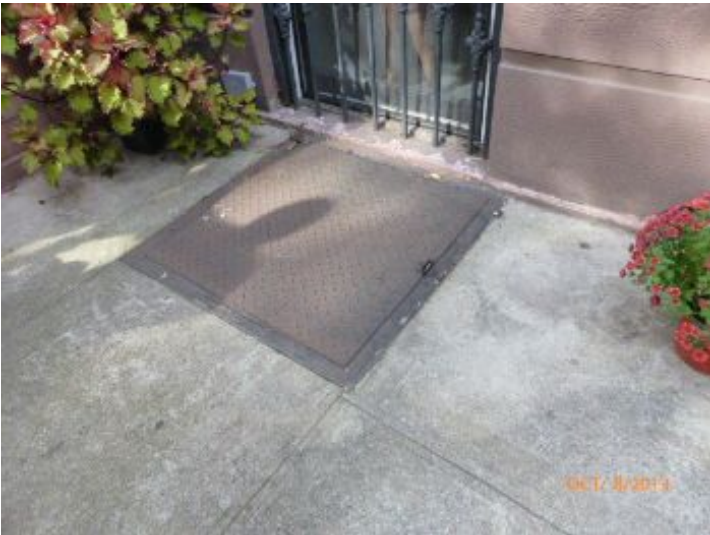
- Appeared in functional condition, at time of inspection.
- Steel trap doors at front and rear ventilation shafts are not weather tight type doors and water can intrude to the basement.
- Exposed/uncaulked wood door saddle observed at rear entrance doorway. A qualified person should correct as needed to help prevent water penetration and deterioration.

Ventilation shaft cover

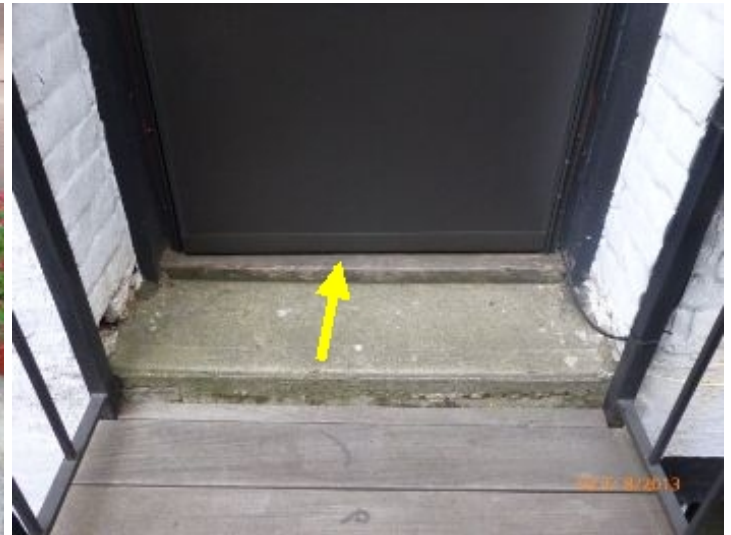
Exposed wood saddle at rear entrance door

<i>Exterior</i>		
Page 3 Item: 4	Exterior Doors	<ul style="list-style-type: none"> Exposed/uncaulked wood door saddle observed at rear entrance doorway. A qualified person should correct as needed to help prevent water penetration and deterioration.
Page 4 Item: 5	Exterior wall covering	<ul style="list-style-type: none"> Peeling paint and some light cracking noted at front of building. Small patch of missing cement cladding noted at rear of building, one damaged brick noted near second floor rear entrance area. Correct as needed.
Page 5 Item: 6	Eaves, Soffits, Fascias, Cornice	<ul style="list-style-type: none"> Front cornice is weathered, exposed wood present. Patching with sheet metal noted at various locations at front and rear cornice. I recommend a qualified person to correct as needed.
<i>Roofing</i>		
Page 8 Item: 4	Flashings	<ul style="list-style-type: none"> Cracked flashings observed at plumbing vent, a qualified person should correct as needed.

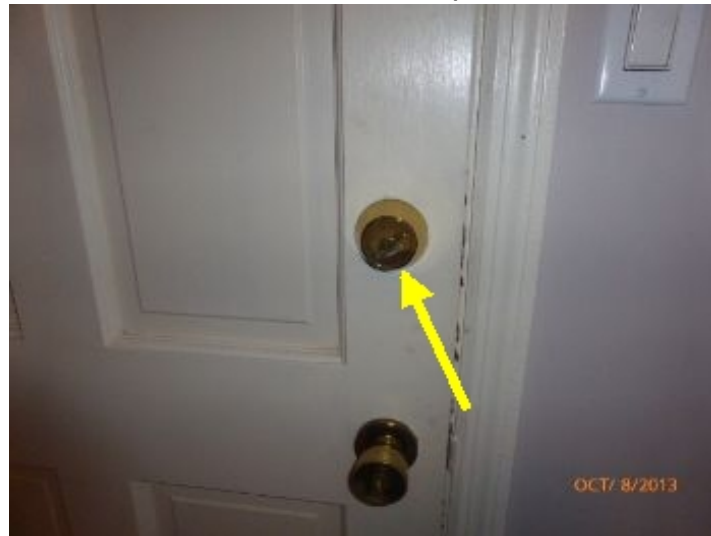
Double keyed deadbolt

- Tested doors appeared functional, at time of inspection.
- SAFETY: double sided keyed deadbolt observed at apartment rear entry door. This condition makes it difficult to exit in case of a fire, recommend single sided keyed deadbolt.
- Lower deadbolt does not function at front apartment entrance door.

Page 20 Item: 5	Interior Doors	<ul style="list-style-type: none"> SAFETY: double sided keyed deadbolt observed at apartment rear entry door. This condition makes it difficult to exit in case of a fire, recommend single sided keyed deadbolt. Lower deadbolt does not function at front apartment entrance door.

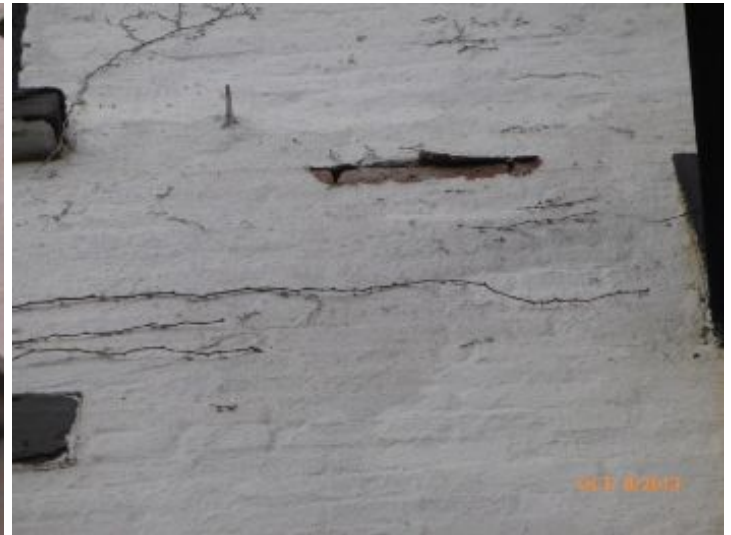
- Exterior wall covering is in serviceable condition, except as noted.
- Peeling paint and some light cracking noted at front of building. Small patch of missing cement cladding noted at rear of building, one damaged brick noted near second floor rear entrance area. Correct as needed.

Patch of missing cement cladding

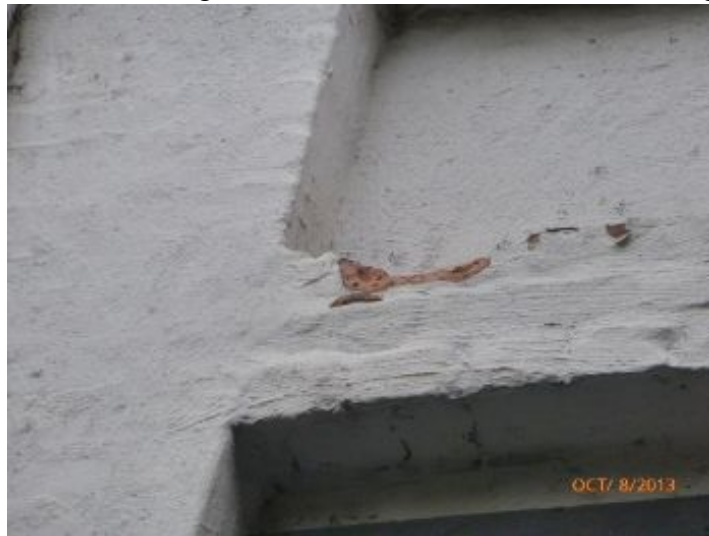
Damaged Brick

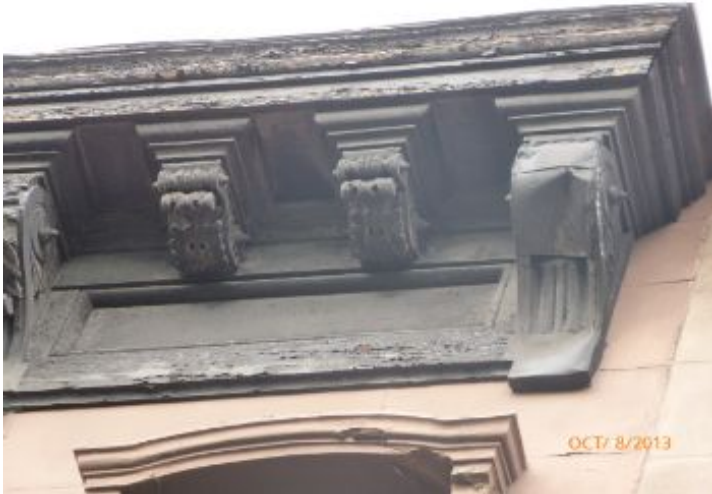
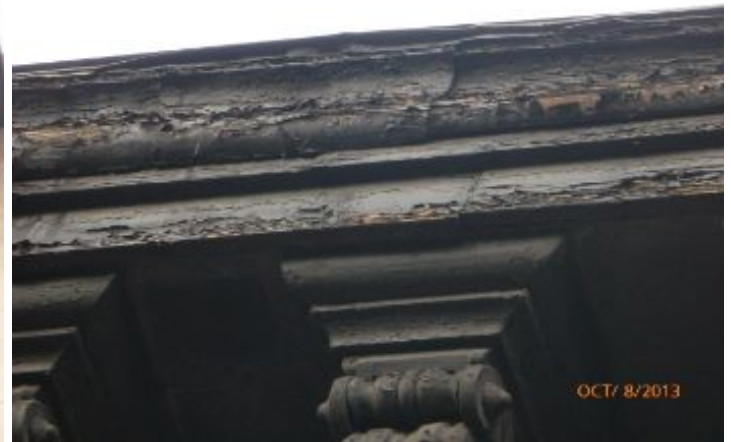
- Front cornice is weathered, exposed wood present. Patching with sheet metal noted at various locations at front and rear cornice. I recommend a qualified person to correct as needed.

Weathered/patched Cornice

Front Cornice

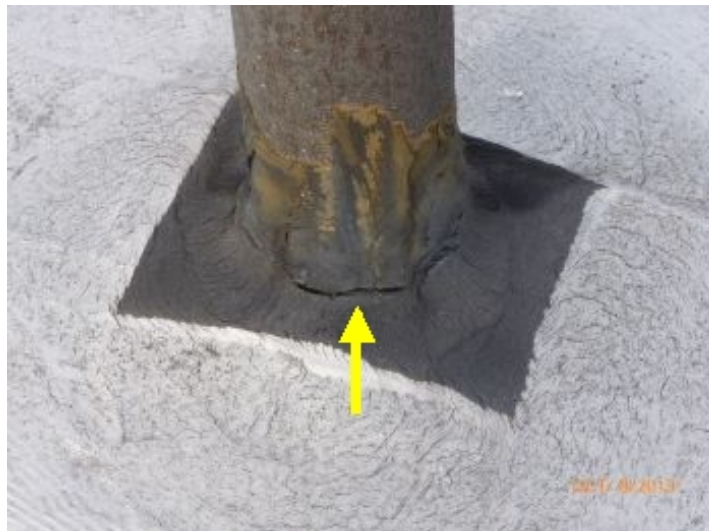
- Cracked flashings observed at plumbing vent, a qualified person should correct as needed.

Crack flashing

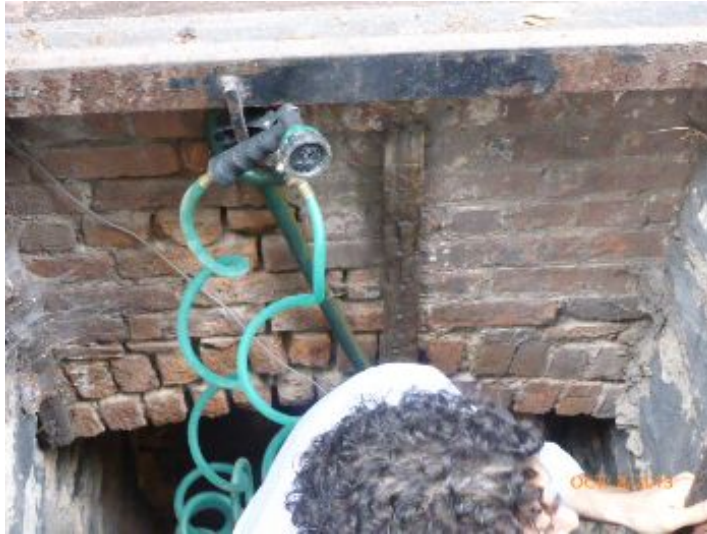
- Foundation walls are generally in serviceable condition, except as noted.
- Limited review due to storage
- Deteriorated/missing mortar noted at walls of front and rear ventilation shafts, some voids between stones noted. I recommend a qualified person to correct as needed.

Deteriorated mortar at ventilation shafts

<i>Structural Components</i>		
Page 11 Item: 2	Foundation Walls	<ul style="list-style-type: none"> Deteriorated/missing mortar noted at walls of front and rear ventilation shafts, some voids between stones noted. I recommend a qualified person to correct as needed.
Page 11 Item: 3	Foundation Floor	<ul style="list-style-type: none"> Dirt basement floors are prone to be high moisture areas and prone to insect issues.
Page 12 Item: 6	Floor Structure	<ul style="list-style-type: none"> Light sloping floors observed, correct as needed.
<i>Heating and Air Conditioning</i>		
Page 13 Item: 4	Distribution Systems	<ul style="list-style-type: none"> One radiator at the bedroom and one at the bathroom have been removed.
Page 14 Item: 10	Fireplace	<ul style="list-style-type: none"> Recommend having flue and/or damper cleaned and inspected by a licensed chimney sweep professional before use.
<i>Electrical</i>

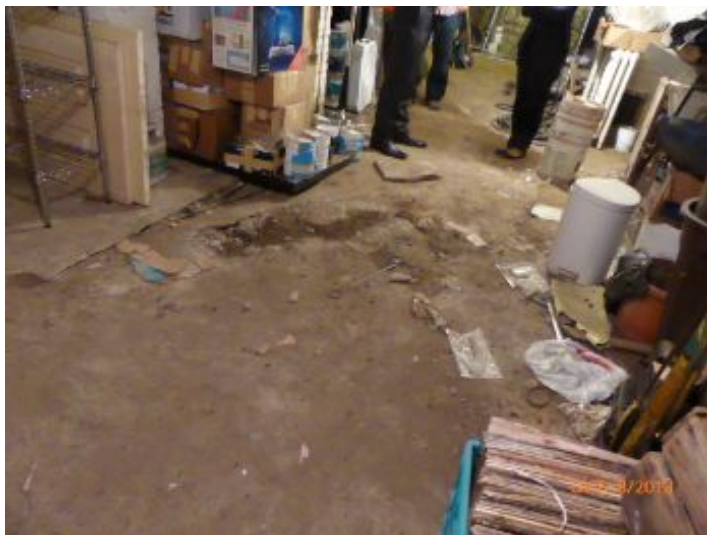
Observations: Dirt basement floors are prone to be high moisture areas and prone to insect issues.

Dirt foundation floor

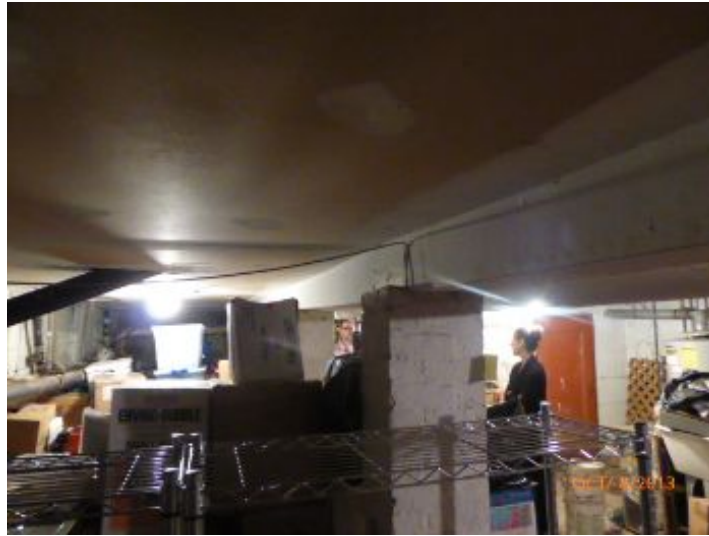
- No visible deficiencies observed.
- Limited review only due to 100% finished ceiling in basement.
- Light sloping floors observed, correct as needed.

Full Ceiling installed in basement

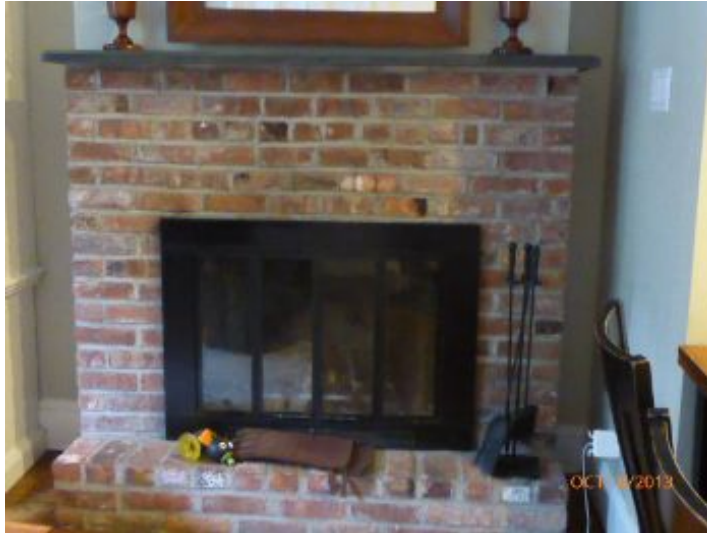
Fireplace

- Recommend having flue and/or damper cleaned and inspected by a licensed chimney sweep professional before use.
